THE EFFECTIVE REMOVAL OF FeCO_3 DEPOSITS FROM CRITICAL PROCESS HEAT EXCHANGERS USED IN AMMONIA PRODUCTION USING A PROPRIETARY ULTRASONIC CHEMICAL CLEANING METHOD

R. Phillion¹ and T.R. McCartney²

ABSTRACT

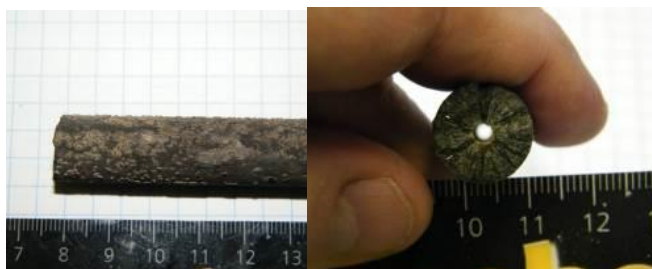
Figure 2. Samples of crystalline deposit (FeCO_3) removed from a tube side from Lean-Rich amine exchanger.

The main fouling component FeCO_3 (*siderite*) had been the main problem of concern for over the past 25 years. Turn-around crews employed everything from the latest high pressure water cleaning 'rotating tips' at 40, 000 PSI, to the harshest of chemical including HCL baths to break out the siderite from the tubes. From recent accounts using these methods our client reported that each method provided minimal cleaning results with major expense involved with the amount of "rotating tips" destroyed, chemical stress fracturing of tubes, significant water used in the cleaning process and the over-all time required to clean just 4 units of the one train of 106C Hx Units.

7. The cleaning process did not have to dissolve all of the tube contamination in to solution to be effective. By shrinking and loosening the adherence of the fouling from the inner walls, the interval water lancing easily removed these large cylindrical chunks of siderite.

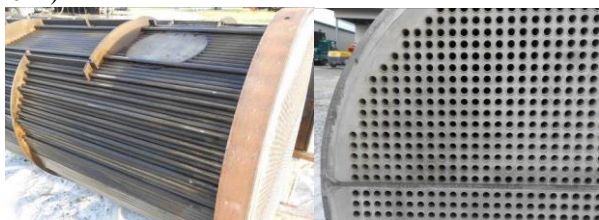
Figure 3. C105A Before cleaning

The refinery agreed to consider a cleaning proposal based on a proven, ultrasonic cleaning method. Historical data revealed heavy deposits of $FeCO_3$ within the ID of the tubes in at least 3 of the 4 Hx units. There wasn't anything noted about the level of difficulty in cleaning the shell-side of these bundles.

It was determined that to effectively remove the siderite from the interior diameter of the tubes, a new companion chemistry to work alongside the ultrasonics, would need to be added. Based on further analysis and solubility testing, the selection of a proprietary organic acid (Paratene®M390)

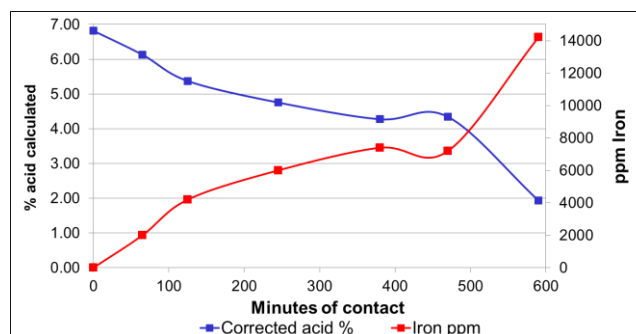
Figure 5. Reaction Rate of Paratene® M390 on deposit over time

Figure 5., shows little or no reaction initially as the solution is heating up, but a rapid dissolution of the solids is seen once a range from 40 and 50°C is reached. The solution stabilizes at about 4% iron. The ultrasonic activity or cavitation process provides both a mechanical surfaces cleaning along with the optimal temperature range that promotes the rapid dissolution of these solids. This acceleration or multiplier effect of the reaction rate offered by the engineered ultrasonic process is a key component toward reducing the overall cleaning time for these heat exchangers. While the use of ultrasonics combined with aqueous based chemistries could technically be deemed as 'ultrasonically aided chemical cleaning, it wasn't until this project where Paratene®M390 was collaborated with a specified ultrasonic cleaning protocol, that coined the phrase—*ultrasonic chemical cleaning* became mainstream within the industrial cleaning community.

To determine the reaction rates in Paratene®M390 a large deposition sample was placed in 100ml of 8% acid. A 0.5ml sample was taken at intervals of time and was then analyzed by ICP.
